FIELD INSPECTION

Project Name:	Mountain Valley Pipeline	Inspector:	Matthew Grant
Inspection Date:	Tuesday, July 23, 2019	Project Contact:	Brian Clauto
Spread: Montgomery Co. MP228-229 St12070-12102+64	Spread H	Weather (Wet/Dry/Rain):	Rainy

FIELD INSPECTION PHOTO LOG

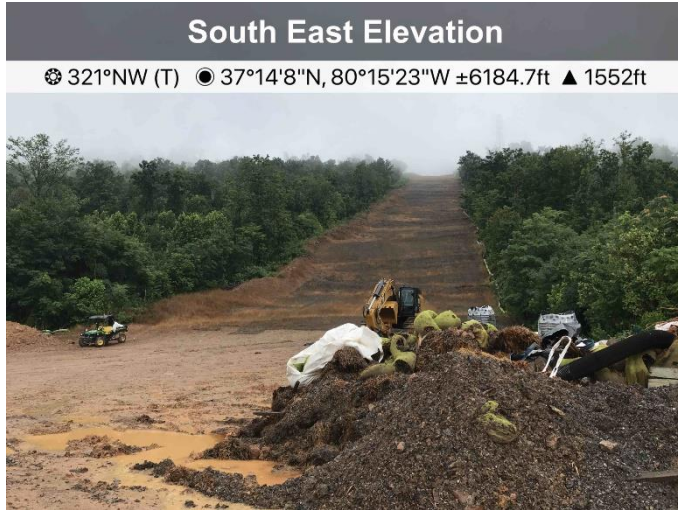
- Fig. 1 At St12070+00 slope remains matted and stabilized.

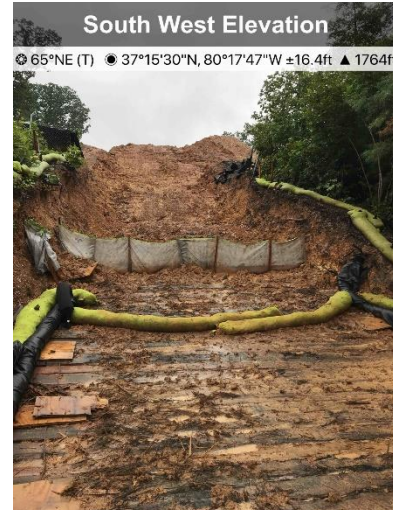
- Fig. 2 Designated stream MM15 crossing, ECD's in place and functioning.

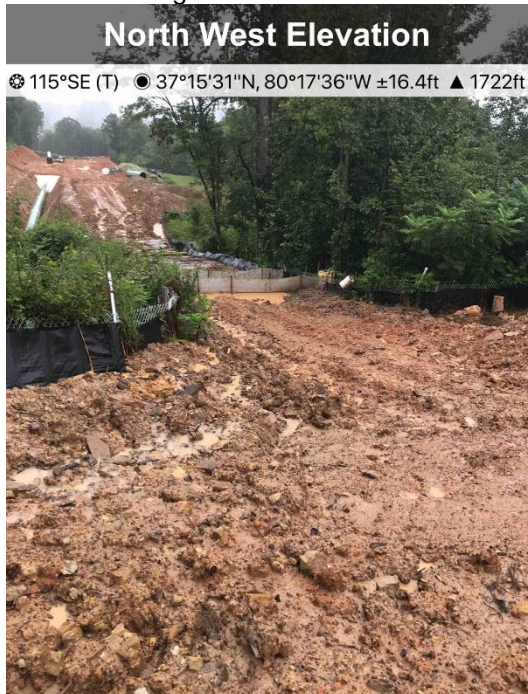
- Fig. 3. Designated stream MM14 crossing, ECD's in place and functioning.

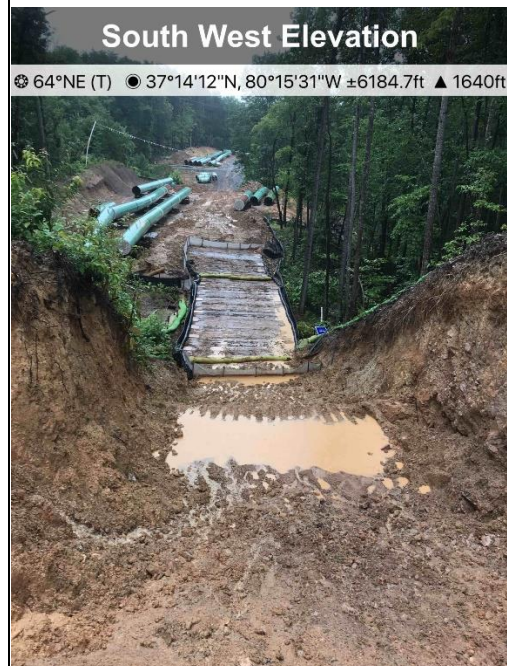
- Fig. 4. Designated stream MM13 crossing, ECD's in place and functioning.
